**INDIAN RAILWAY INSTITUTE OF CIVIL ENGINEERING  
PUNE 411001**

**PROJECT REPORT**

**A CASE STUDY ON  
REPLACEMENT OF SCREW PILES  
BY  
WELL FOUNDATION  
UNDER RUNNING TRAFFIC**

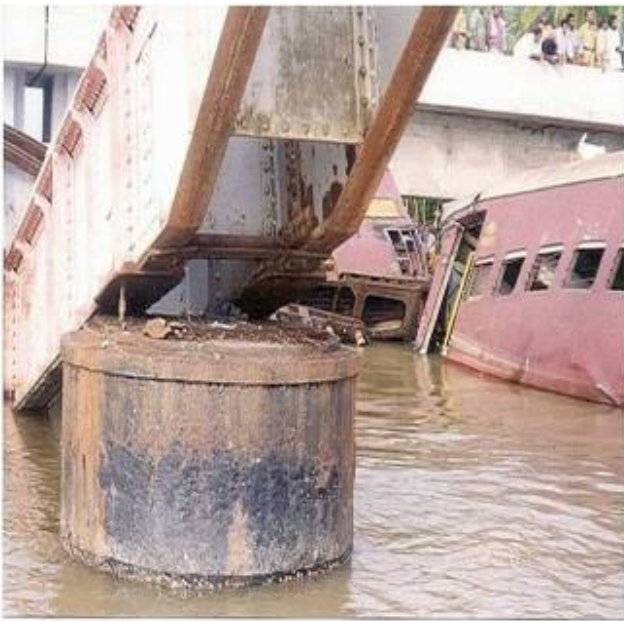
*Photograph showing the accident of Exp.train  
At Kadalundi Bridge.*

*In the year 2001, there was an **accident of Express train No:6602** – (running between Mangalore-Chennai) at Bridge No:924(Kadalundi) in Shoranur Junction – Mangalore Junction. section of Southern Railway. **with span 12x19.51m steel girder on Cast iron screw piles resulting loss of 52 human lives and 105 grievously injured.***

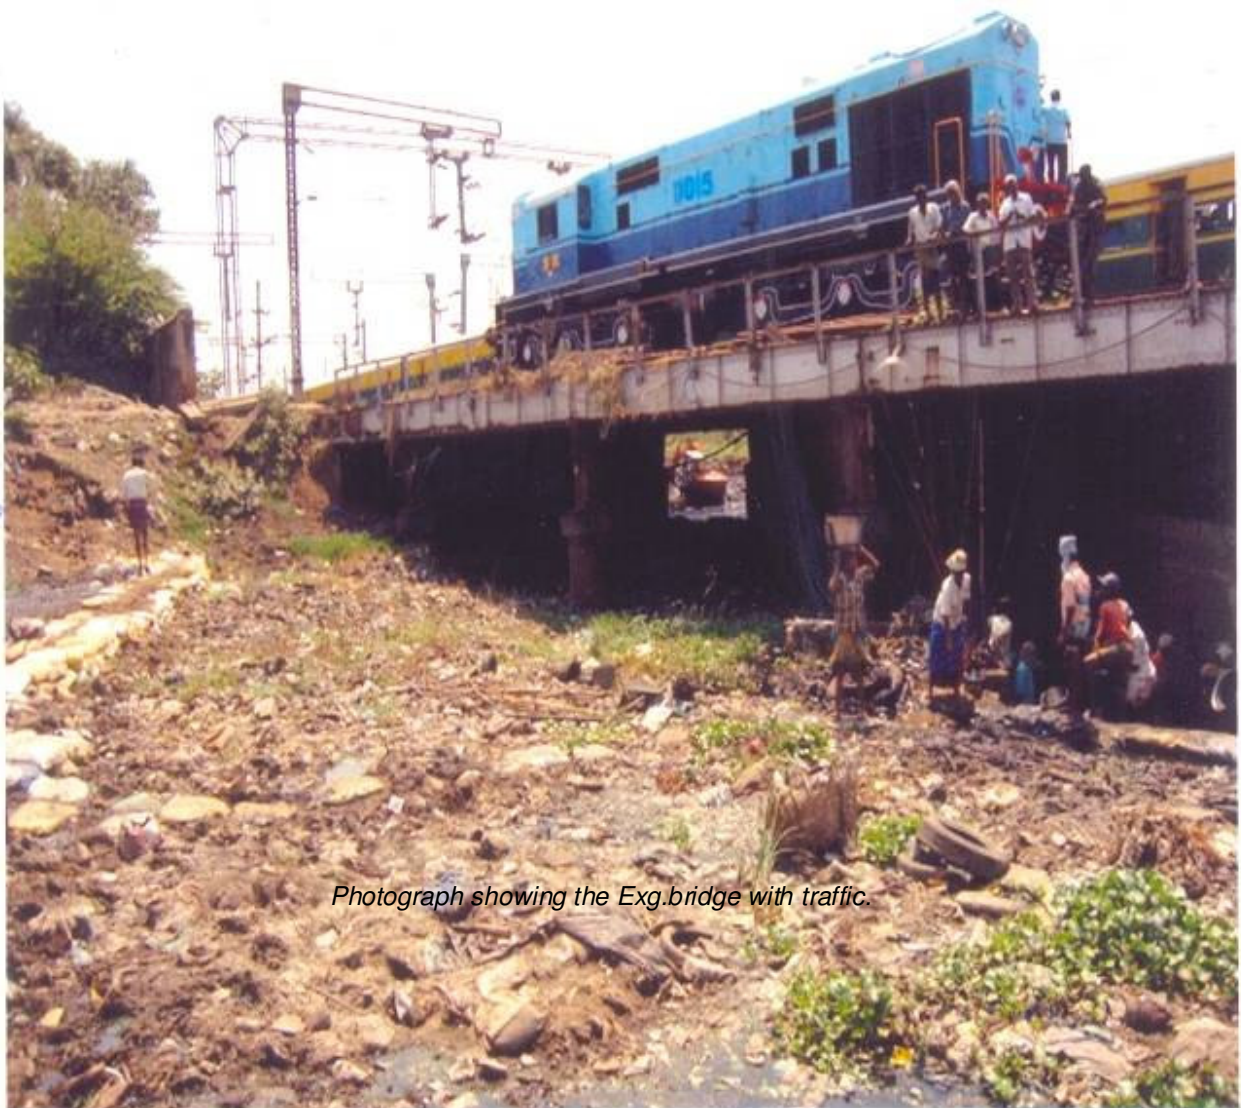
*Photograph showing the Exg.bridge with traffic.*

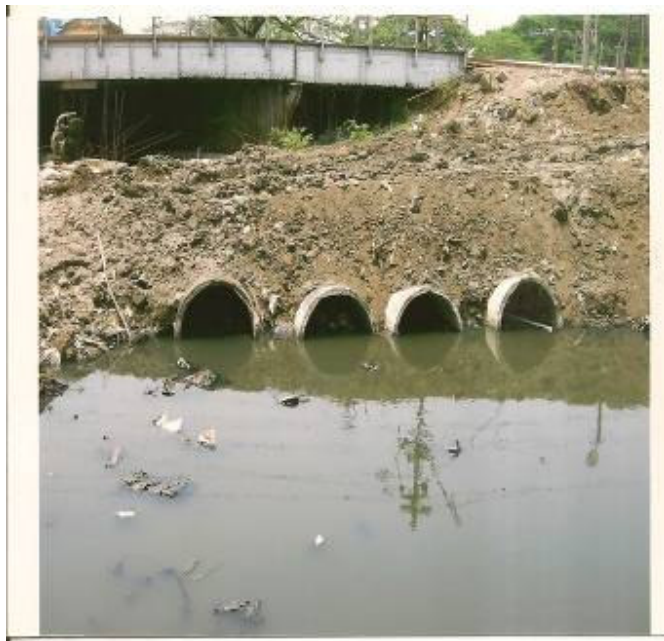
*Photograph showing Approach Road*

For the movement of Transit mixers carrying concrete and trucks carrying other materials approach road have been formed on a bigger way on the down stream end and comparatively smaller way on up stream end . Laying RCC pipes beneath the approach road for the through flow of water has also been ensured.

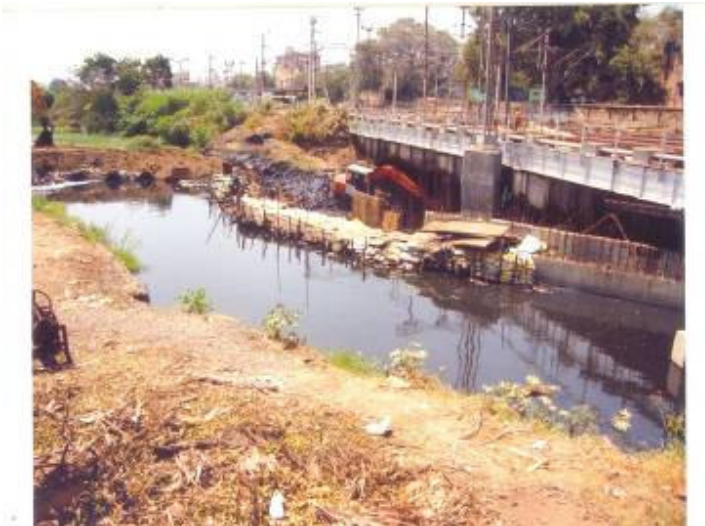
***Photograph showing coffer Dam***

- A coffer dam has been provided between span No 3 & 4 from the upstream end to a length 30 metres from the bridge and extended to a length of 40 metres for the downstream end duly permitting the flow through span 4, 5 & 6.

The coffer dam has been constructed by removing the silt up to the bed level completely.

Two rows of casurina post driven at an interval of about 1.50 m centre to centre and anchored by 1 m into ground level, horizontal connection has been made to the vertical casurina post. at an interval of 0.60m duly ensuring the width of coffer dam as 1.50m for the entire length extending for the 30m on upstream and 40 m Downstream.

Earth packed Gunny bags laid closely between the vertical casurina posts .

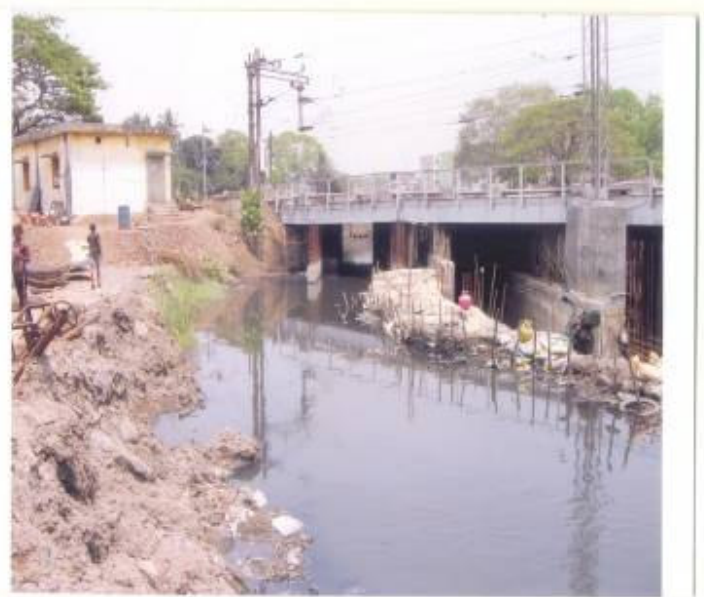
***Photograph showing coffer Dam***

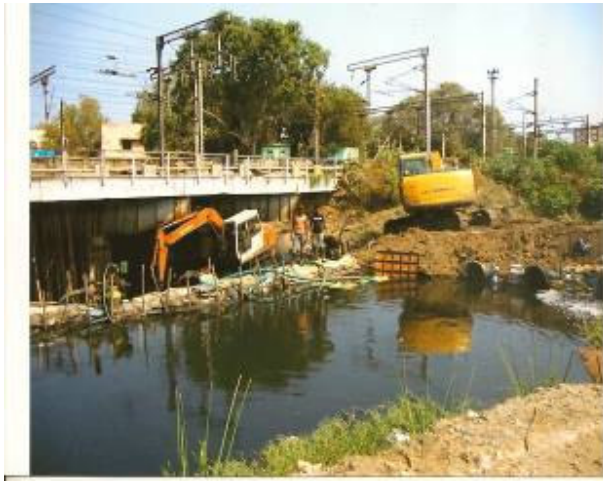
The surface flow carried on this water course transmits fine grained soil mass of huge volume along with it and these soil mass get deposited in the water way of the bridge as well as on the upstream end of the bridge.

It has been observed that silt exist for the depth of more than 2.50 metre above the bed level of the bridge portion as well as on the Upstream end. It is also seen some organic materials also getting deposited.

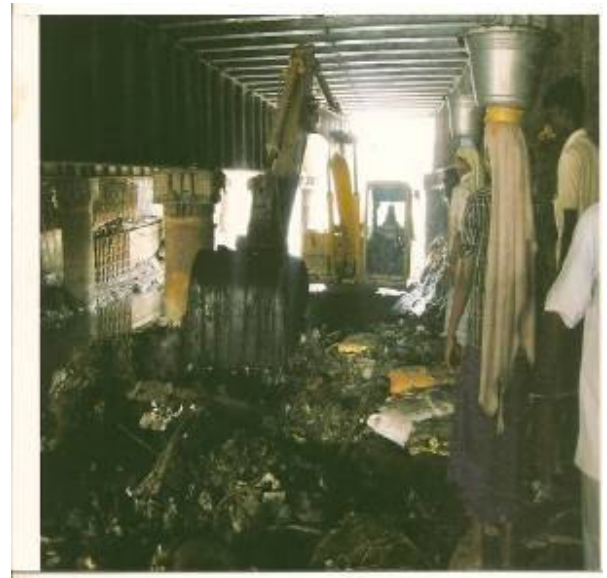
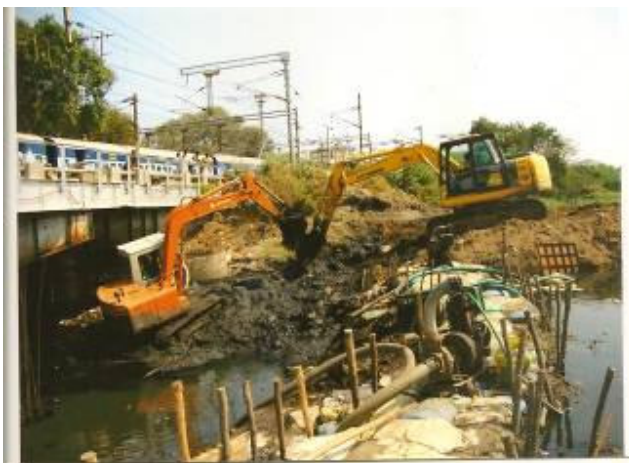
One poclairn of capacity of D 60 was taken inside the span and D 120 has been deployed near the end span.

De silting has been carried out with the help of D120 and D60 in the proposed span A & B . Silt has been removed up to the bed level.

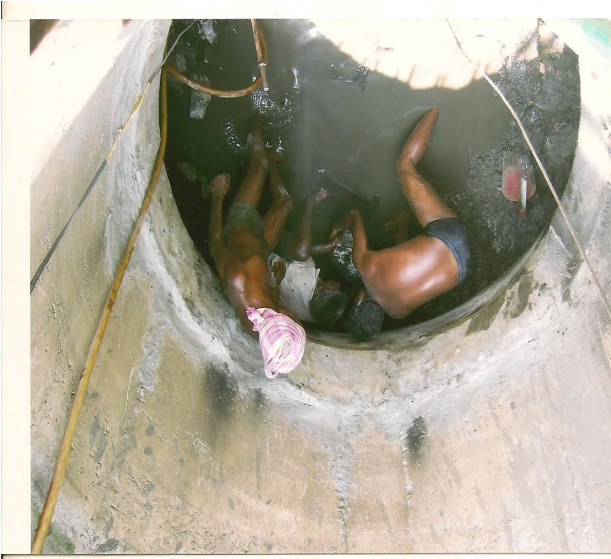
The cross girders resting on screw piles have been temporarily supported using steel cribs and wooden blocks enabling suitable space for the sinking of wells which also ensures against

the safety in the event of settlement of screw piles during the sinking of wells .

Well sinkers have been deployed for sinking. Manual extraction of the material has been carried out inside the well, the excavated material was brought out by bucket and pulley arrangement to the bed level.

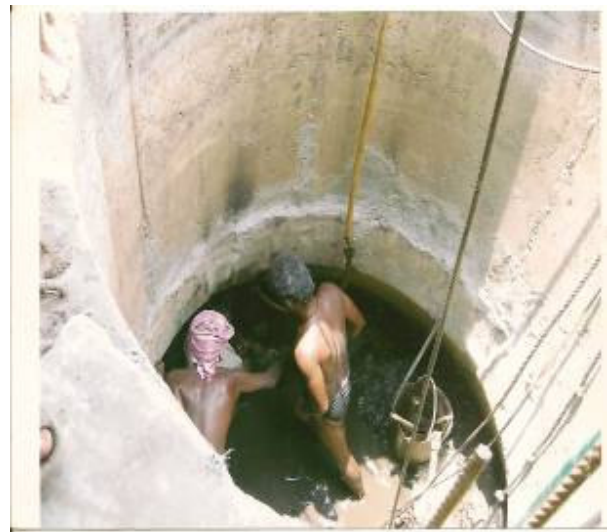
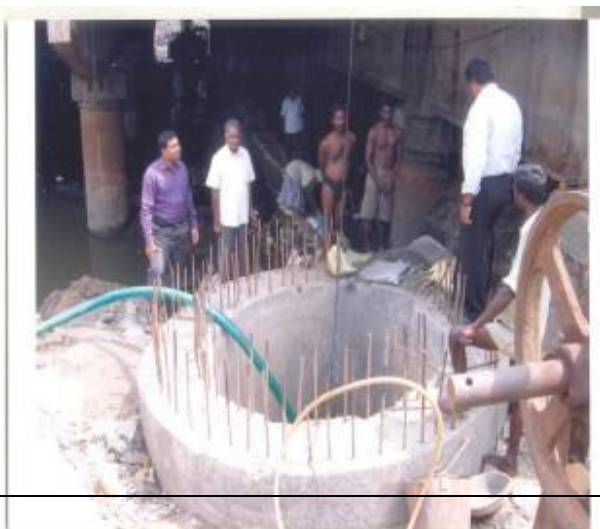
After sinking of well about 3 to 4 metres, the sinkers have been provided with life saving supports

The well has been founded by suitably resting on hard rock at a depth of 13 to 15m. In these process, sinking of all the wells have been completed.

After complete sinking of the well bottom plug has been provided by using plain concrete to the depth of 1250mm.

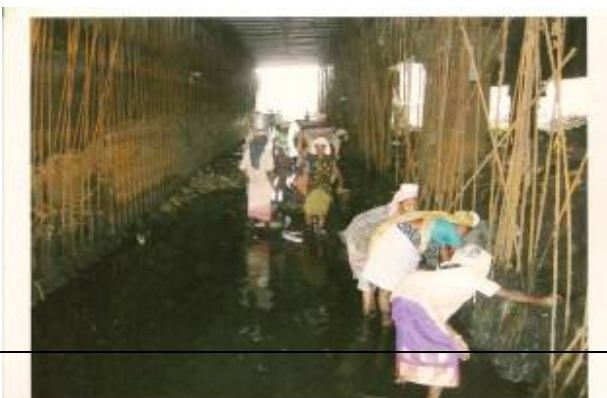
Construction joints for a width of 40mm has been provided at a distance of 1.5 m from the center line of the screw piles.

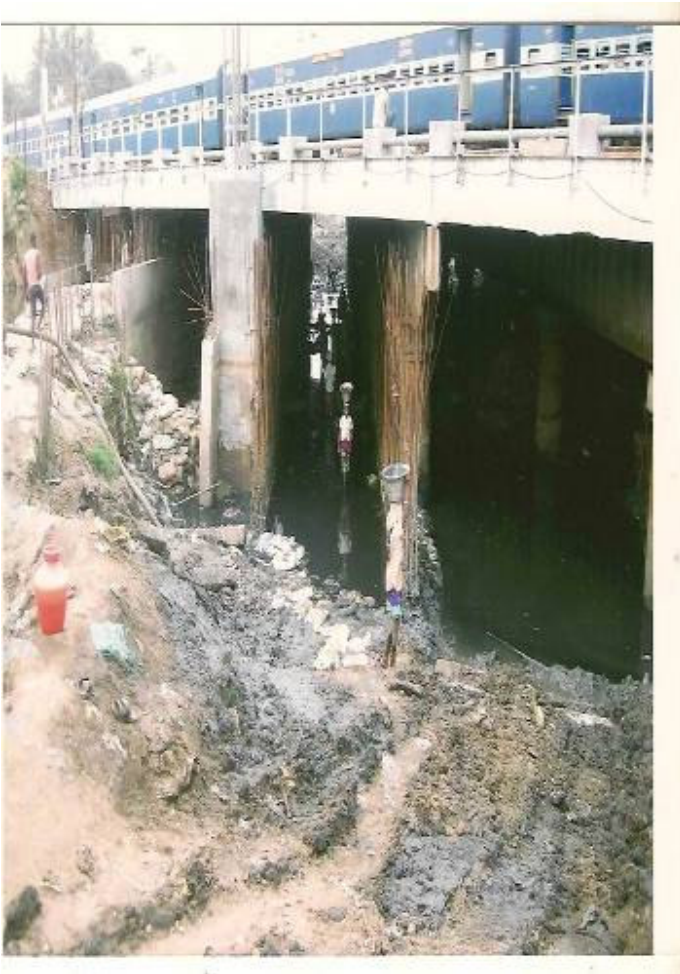
Distributor reinforcements have been introduced to the vertical reinforcements for the side walls of the box already provided.

Initially the hunch portion 150 x 150mm has been constructed on both sides throught the length duly providing appropriate shuttering arrangement.

Shuttering for the wall portion for the height of 1m has been made throught the length on both sides simultaneously.

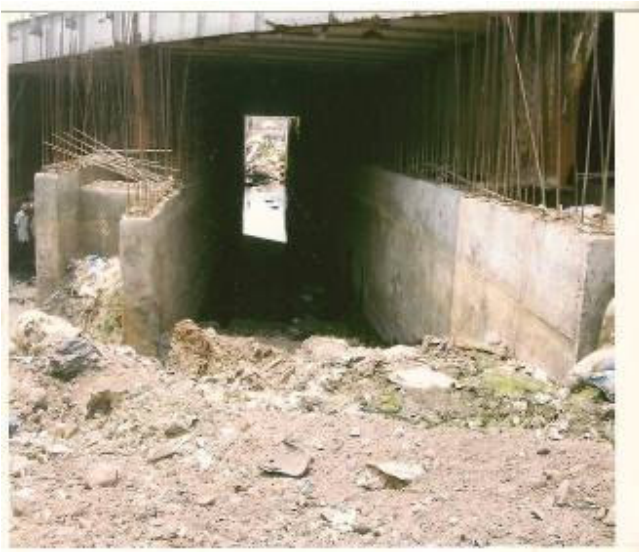
The gap between the walls of the RCC Box segments of adjacent spans have been filled with plain concrete of M 20 immediately after the construction of the side wall for a height of 1 m both adjacent spans, since filling up the gap cannot be carried out in later stages,

Filling up of the mass concrete covers the screw piles and screw piles get encased in the mass concrete simultaneously.
